# AEROSPACE RECOMMENDED PRACTICE

**ARP6225™****REV. B**Issued 2014-11  
Revised 2023-03

**(R) Aircraft Tire Inspection - In-Service Removal Criteria**

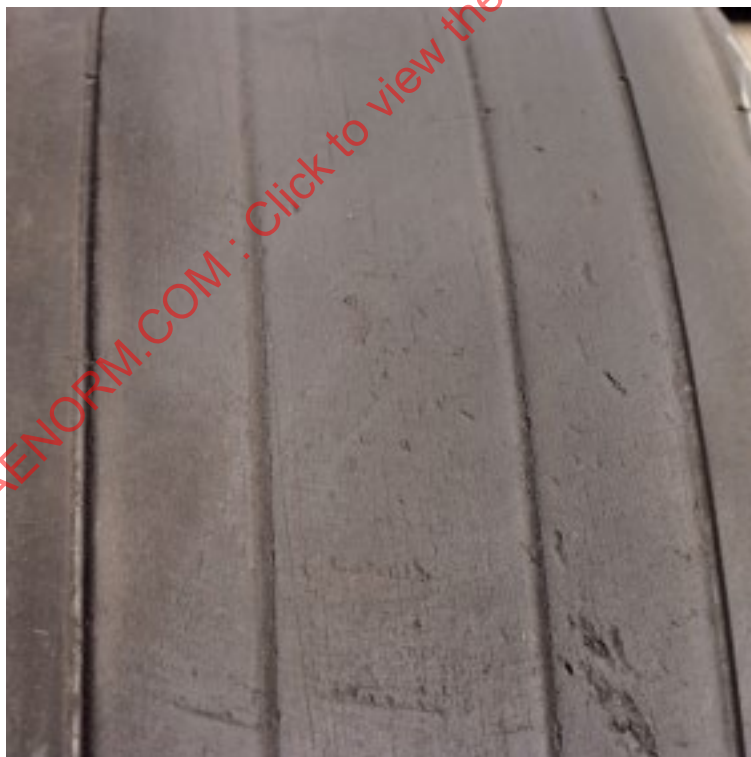
An even tread wear indicates that the tire has been properly maintained during its service life.

**REMOVAL LIMIT:** Remove tire when the bottom of any groove at one point up to 1/8 of the tire circumference is reached (Figure 3), or when any fabric or metallic material is exposed at any location over the tread surface, WHICHEVER COMES FIRST (Figures 4 and 5).

**Figure 3 - Normal wear**

| <b>TREAD WEAR CRITERIA</b> | | |
|---|---|---|
| <b><u>Normal Wear</u></b> | An even tread wear indicates that the tire has been properly maintained during its service life. | <p>Remove tire when the wear level criteria is reached (Figure 3), or when any fabric is exposed at any location over the tread surface, WHICHEVER COMES FIRST (Figures 4 and 5).</p> <p>NOTE: If the wear removal criteria is met at an outstation where maintenance is not available, the aircraft manufacturer should be contacted to assure the tire may remain in service and if any additional tire inspections are required prior to each aircraft departure before arriving at a suitable maintenance base for a wheel and tire assembly replacement. This should be accomplished as soon as possible. However, if any fabric or metallic material is exposed, the tire should be removed immediately</p> |

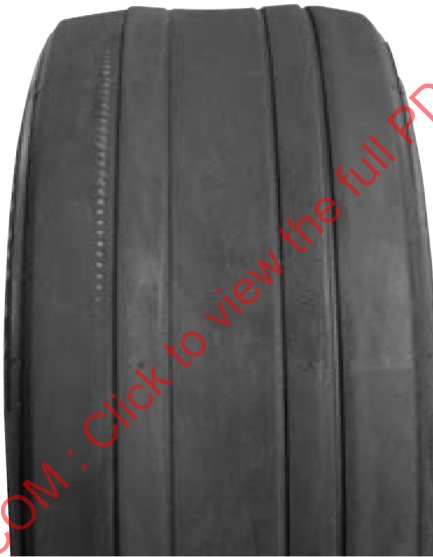
Under-inflation can lead to excessive tread shoulder wear. It will lead to high tire deflection and subsequent heat build-up, which may result in severe tire damage. The cause for operating underinflated should be investigated by the operator and corrective actions taken (Figure 4). Underinflated tires should be corrected per the tire maintenance schedule of ARP5265 and the AMM.

**Figure 4 - Shoulder wear**

**REMOVAL LIMIT:** Tires with uneven wear should be removed from the aircraft if the wear limits (defined under normal wear) are reached.

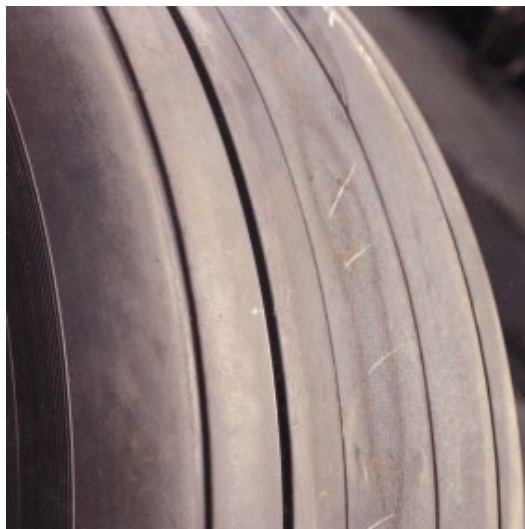
Over-inflation can accelerate the center tread wear, reduce tire traction, reduce the number of landings per tread, and make the tire more susceptible to cutting and foreign object damage (FOD) (Figure 5). Overinflated tires should be corrected per the tire pressure maintenance schedule of ARP5265 and the AMM.

**Figure 5 - Center wear**

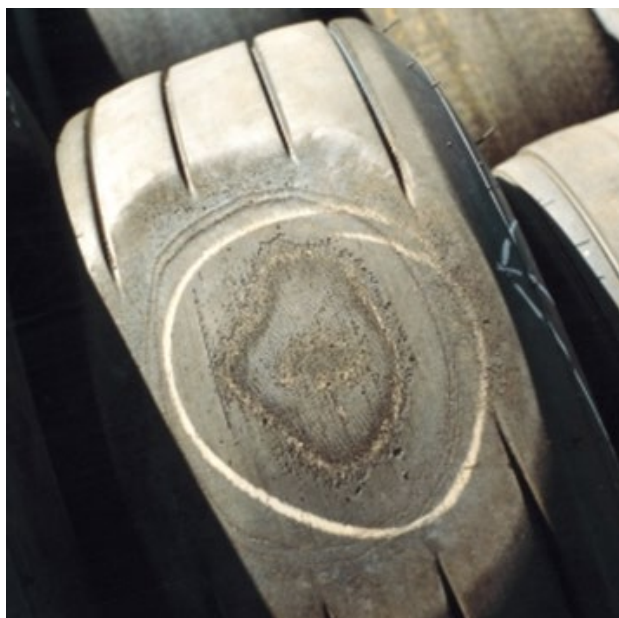
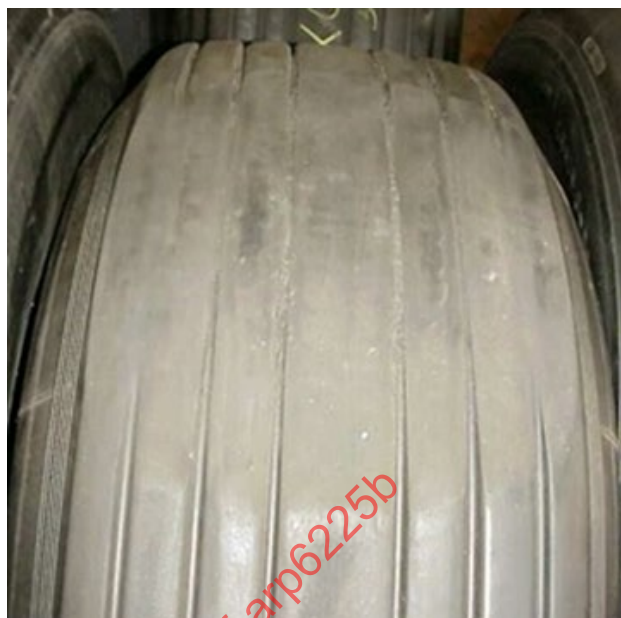
**Figure 7 - Flat spot**

Tread flat spot or severe tread rubber abrasion results from steering maneuvers prior to aircraft rolling, or the locking of the wheel during braking or touchdown (Figure 7).

Locked wheel tire flat spot

Typical tire flat spot

| <b>TREAD DAMAGE CRITERIA</b> | | |
|---|---|---|
| <b><u>Flat Spots</u></b> | Tread flat spot or severe tread rubber abrasion results from steering maneuvers prior to aircraft rolling, or the locking of the wheel during braking or touchdown (Figure 7). Flat spotting due to cold temperature or prolonged parking is not a condition for tire removal. | The tire should be removed from the aircraft when the flat spot damage exceeds the wear removal criteria of 5.1. |

REMOVAL LIMIT: The tire should be removed from the aircraft when the flat spot damage exceeds the wear removal criteria of 5.1.

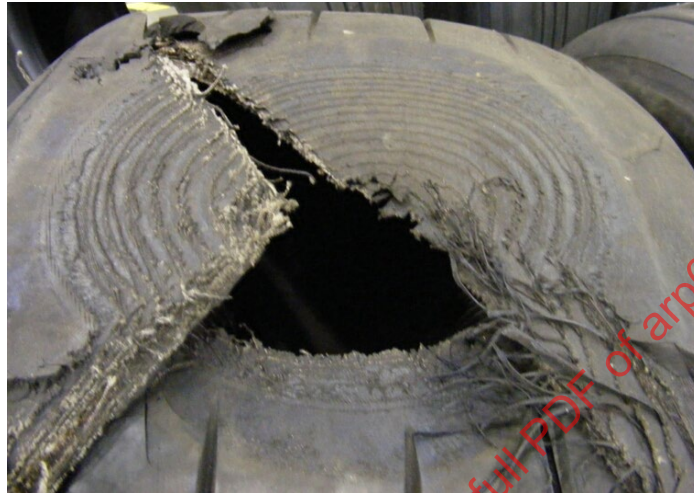
Skid-through burst results from the locking of the wheel. In this case, the tire experiences either a loss of inflation pressure or an explosive blowout (Figure 9).

**Figure 9 - Skid through**

| <b>TREAD DAMAGE CRITERIA</b> | | |
|---|---|---|
| <b><u>Skid-Through Burst</u></b> | Skid-through burst results from the locking of the wheel. In this case, the tire experiences either a loss of inflation pressure or an explosive blowout (Figure 9). | Both the failed tire and axle mate tire should be removed from the aircraft, the burst tire marked as "scrap," and the axle mate tire marked with the removal reason ("mate to flat"). The skid-through tire can be scrapped locally, but the mate to flat tire should be returned to the tire manufacturer or retreader. |

**REMOVAL LIMIT:** Both the failed tire and axle mate tire should be removed from the aircraft, the burst tire marked as “scrap” and the axle mate tire marked with the removal reason (“mate to flat”). The skid-through tire can be scrapped locally, but the mate to flat tire should be returned to the tire manufacturer or retreader.

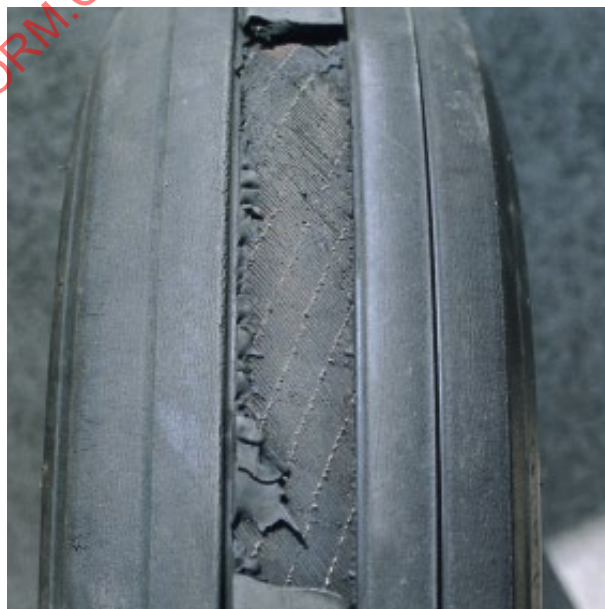
A peeled rib usually starts with a cut or damage in the tread and results in a circumferential delamination of the tread rib away from the tire casing, typically with no loss of reinforcing plies (Figure 10) or tire pressure.

**Figure 10 - Peeled rib**

| <b>TREAD DAMAGE CRITERIA</b> | | |
|---|---|---|
| <b><u>Peeled Rib</u></b> | A peeled rib usually starts with a cut or damage in the tread and results in a circumferential delamination of the tread rib away from the tire casing, typically with no loss of reinforcing plies (Figure 10) or tire pressure. | The tire should be removed immediately from service when the peeled section, regardless of length, is exposing fabric or has fully detached. Pieces from the tread should be requested from airport authorities and returned to the home base for potential analysis by the tire supplier. |

**REMOVAL LIMIT:** The tire should be removed immediately from service when the peeled section, regardless of length, is exposing fabric or has fully detached. Pieces from the tread should be requested from airport authorities and returned to the home base for potential analysis by the tire supplier.

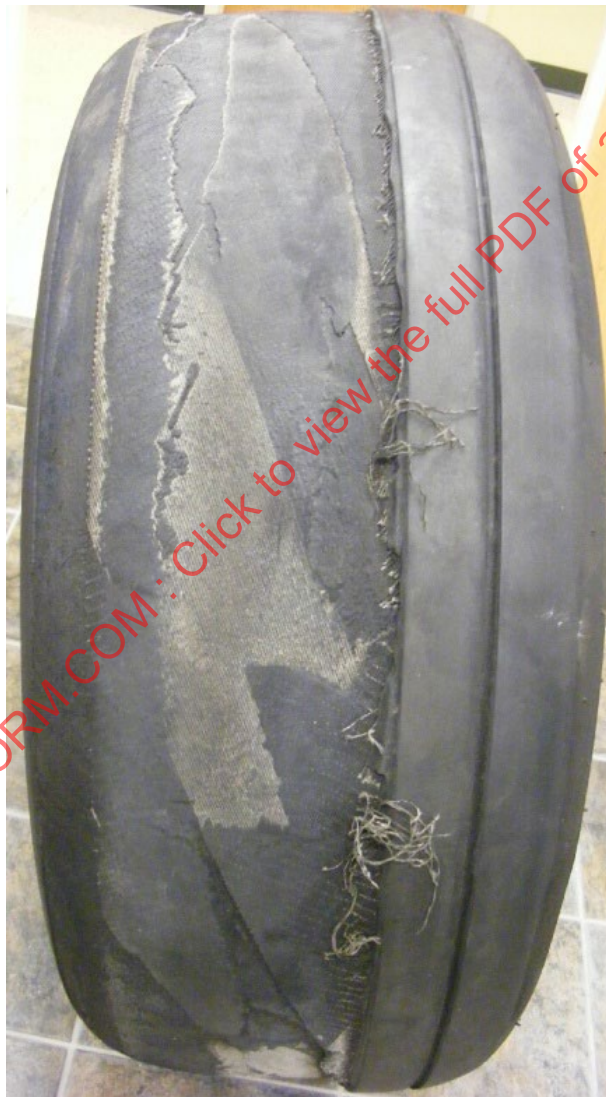
**Figure 11 - Thrown tread**

| <b>TREAD DAMAGE CRITERIA</b> | | |
|---|---|---|
| <b><u>Thrown Tread</u></b> | A thrown tread on an inflated tire is a partial or complete loss of the tread down to the casing plies or tread reinforcing plies/protector ply (Figure 11). | The tire should be removed immediately from service. Pieces from the tread should be requested from airport authorities and returned to the home base for potential analysis by the tire supplier. If the damaged tire is deflated due to a loss of inflation pressure, then the axle mate should be removed also. If the tire is still inflated after the aircraft is parked, if time permits, record the tire pressure after it has cooled down (allow 3 hours). |

REMOVAL LIMIT: The tire should be removed immediately from service. Pieces from the tread should be requested from airport authorities and returned to the home base for potential analysis by the tire supplier. If the damaged tire is deflated due to a loss of inflation pressure, then the axle mate should be removed also.

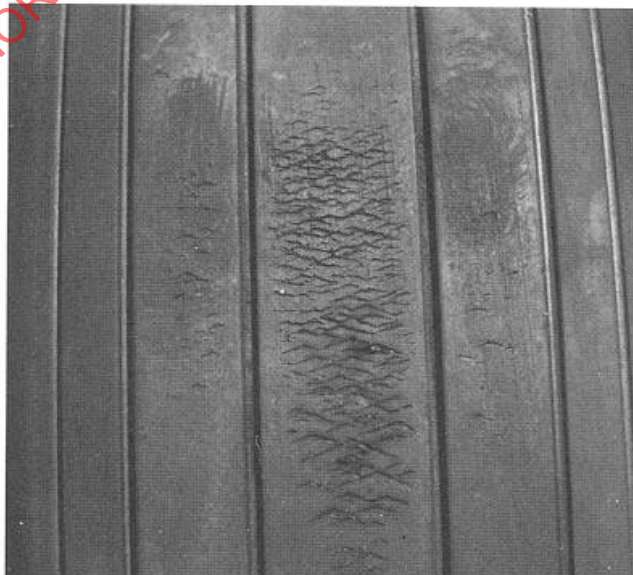
Chevron cutting is tread damage (small z-, s-, or v-shaped tears) caused by touchdown, running, and/or braking on cross-grooved runways (Figure 13). Chevron cutting is a condition of the tread rubber only.

**Figure 13 - Chevron cutting**

| <b>TREAD DAMAGE CRITERIA</b> | | |
|---|---|---|
| <b><u>Chevron Cutting</u></b> | Chevron cutting is tread damage (small z-, s-, or v-shaped tears) caused by touchdown, running, and/or braking on cross-grooved runways (Figure 13). Chevron cutting is a condition of the tread rubber only. | Tire should be removed from aircraft if: <ul style="list-style-type: none"> <li>▪ The tread cut criteria are reached, or</li> <li>▪ Fabric beneath the tread is exposed for more than 1.0 inch<sup>2</sup> (6.45 cm<sup>2</sup>), or</li> <li>▪ The cutting involves the full width of any one of the tread ribs.</li> </ul> |

**REMOVAL LIMIT:** Tire should be removed from aircraft if the tread cut criteria are reached, the fabric beneath the tread is exposed for more than 1.0 inch<sup>2</sup> (6.45 cm<sup>2</sup>), or the cutting involves the full width of any one of the tread ribs.

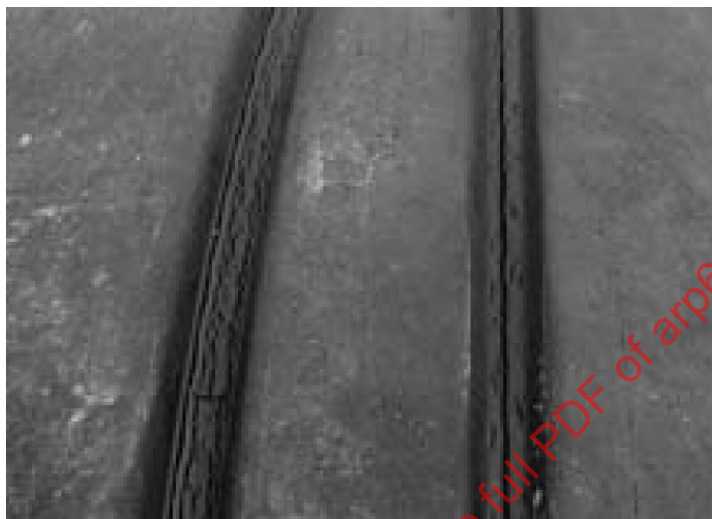
Groove cracking may result from ozone attack of the rubber or excessive flexing of the groove bottoms as a result of insufficient inflation of the tire. These cracks occur along the bottom of tread grooves (Figure 14).

**Figure 14 - Groove cracking**

| <b>TREAD DAMAGE CRITERIA</b> | | |
|---|---|---|
| <b><u>Groove Cracking</u></b> | Groove cracking may result from ozone attack of the rubber or excessive flexing of the groove bottoms as a result of insufficient inflation of the tire. These cracks occur along the bottom of tread grooves (Figure 14). | The tire should be removed immediately from the aircraft if: <ul style="list-style-type: none"> <li>▪ Groove cracking exposes the fabric beneath the tread for more than 0.25 inch (6.35 mm) circumferentially in length.</li> <li>▪ Groove cracking has led to undercutting of the adjacent rib by more than 0.25 inch (6.35 mm).</li> </ul> |

**REMOVAL LIMIT:** The tire should be removed immediately from the aircraft if groove cracking exposes the fabric beneath the tread for more than 0.25 inch (6.35 mm) circumferentially in length or groove cracking has led to undercutting of the adjacent rib by more than 0.25 inch (6.35 mm).

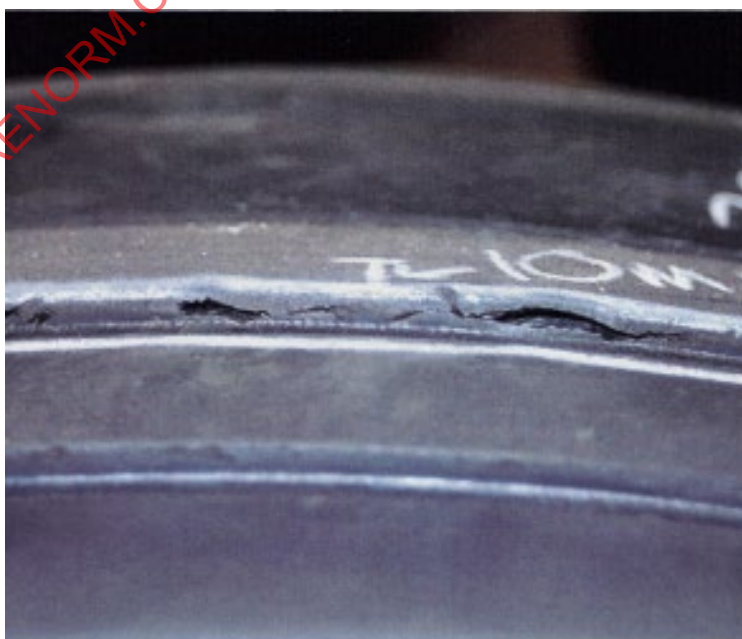
Rib undercutting can be an extension of groove cracking progressing under a tread rib or develop as a break in the groove wall extending under the rib. This can lead to tread chunking, peeled rib, or thrown tread (Figure 15).

**Figure 15 - Rib undercutting**

| <b><u>Rib Undercutting</u></b> | Rib undercutting can be an extension of groove cracking progressing under a tread rib or develop as a break in the groove wall extending under the rib. This can lead to tread chunking, peeled rib, or thrown tread (Figure 15). | The tire should be removed immediately from the aircraft if undercutting extends more than 0.25 inch (6.35 mm) under the tread rib. |

**REMOVAL LIMIT:** The tire should be removed immediately from the aircraft if undercutting extends more than 0.25 inch (6.35 mm) under the tread rib.

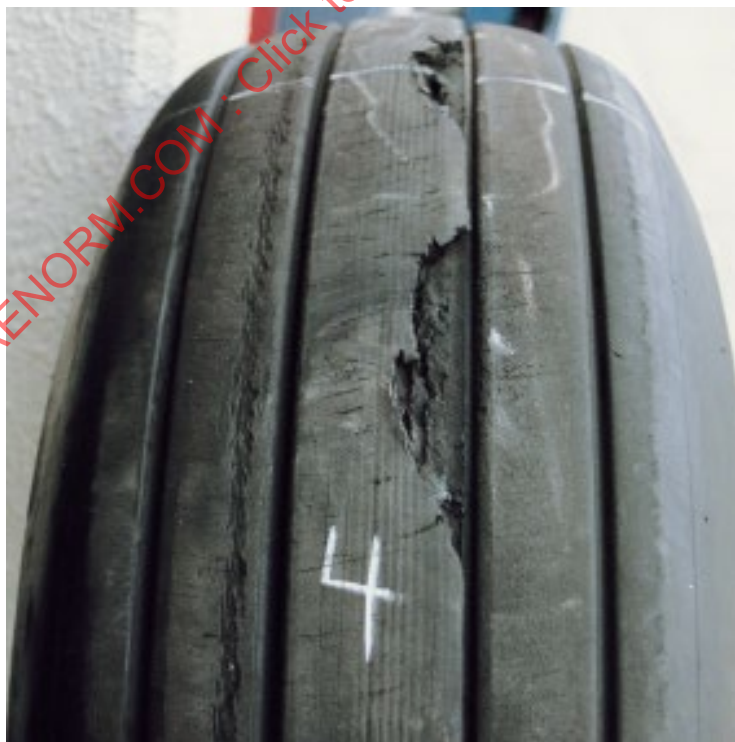
Rib tearing occurs when the tire is subjected to excessive side force during landing or taxiing (Figure 17).

**Figure 17 - Rib tearing**

| <b><u>Rib Tearing</u></b> | Rib tearing occurs when the tire is subjected to excessive side force during landing or taxiing (Figure 17). | The tire should be removed immediately from the aircraft if fabric beneath the tread is exposed for more than 1.0 inch <sup>2</sup> (6.45 cm <sup>2</sup> ) or the damage extends the full width of the tread rib. |

REMOVAL LIMIT: The tire should be removed immediately from the aircraft if cords are exposed for more than 1.0 in<sup>2</sup> (6.45 cm<sup>2</sup>), or if the damage extends the full width of the tread rib.
